Deep Brook Assessment
Newtown, Ct

Rob Walker, Intern

New Town Land Use Agency

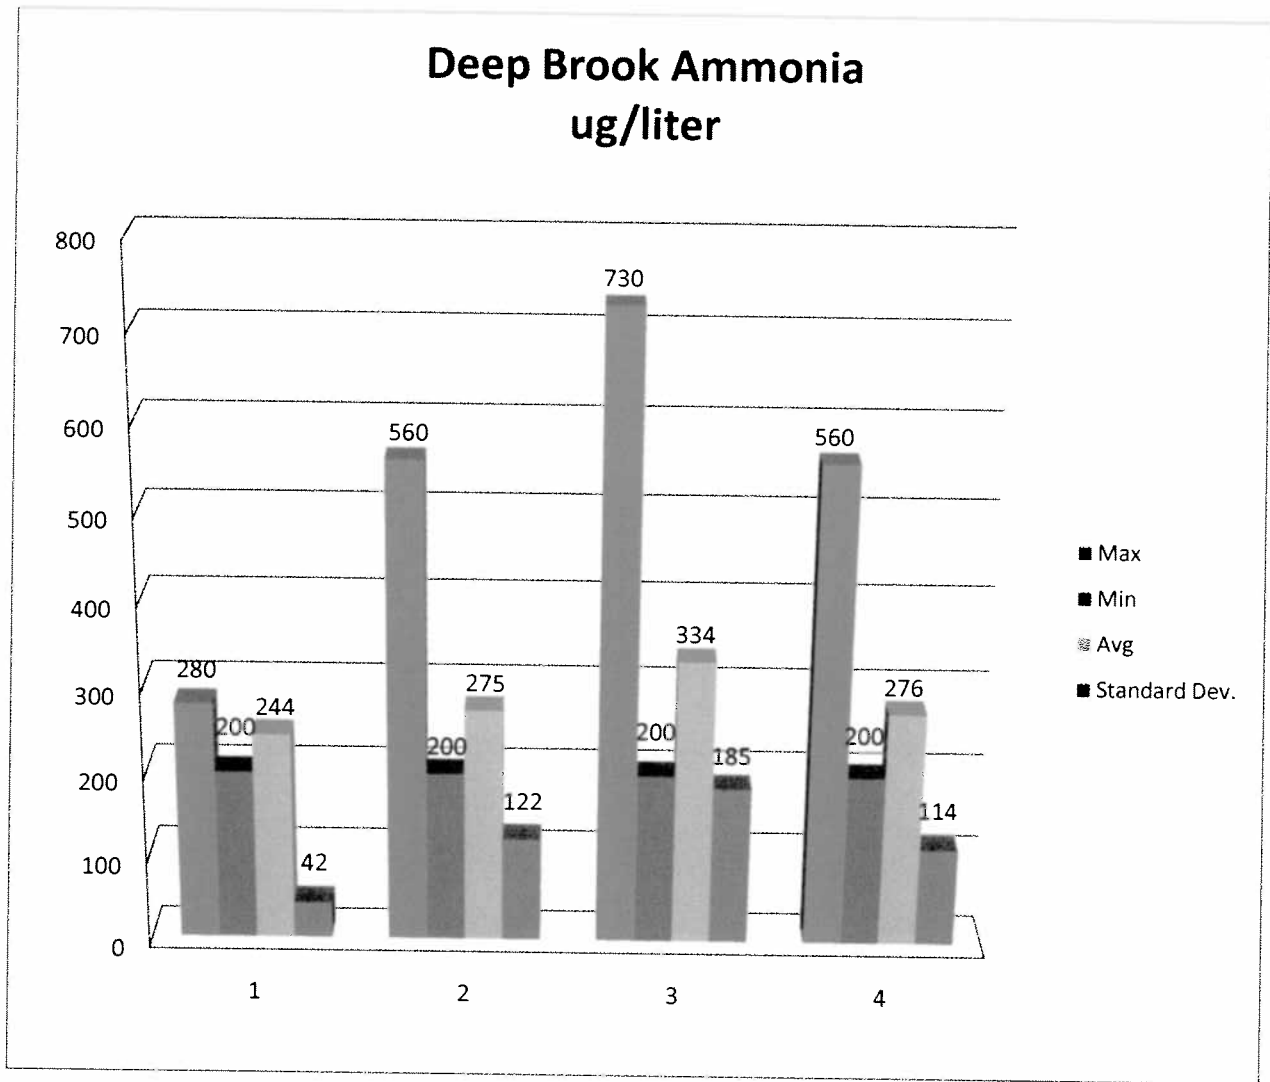
Figure 1

independent. **Figures 1,2 and 3** all show the averages for Ammonia, Conductivity and Phosphorous for each of the 4 sites. Looking at each one it is easy to see that between site 2 and 3 there is a increase, whether it be 560-730 (Ammonia), 226-260 (Conductivity), or stayed constant at a higher number than the rest 80-90 (Phosphorus). **Figure 3** shows that the Max Conductivity for Deep Brook was 358 which is well above the minimum of 160. The average of these parameters increase as the water flows downstream, which is a normal occurring situation.

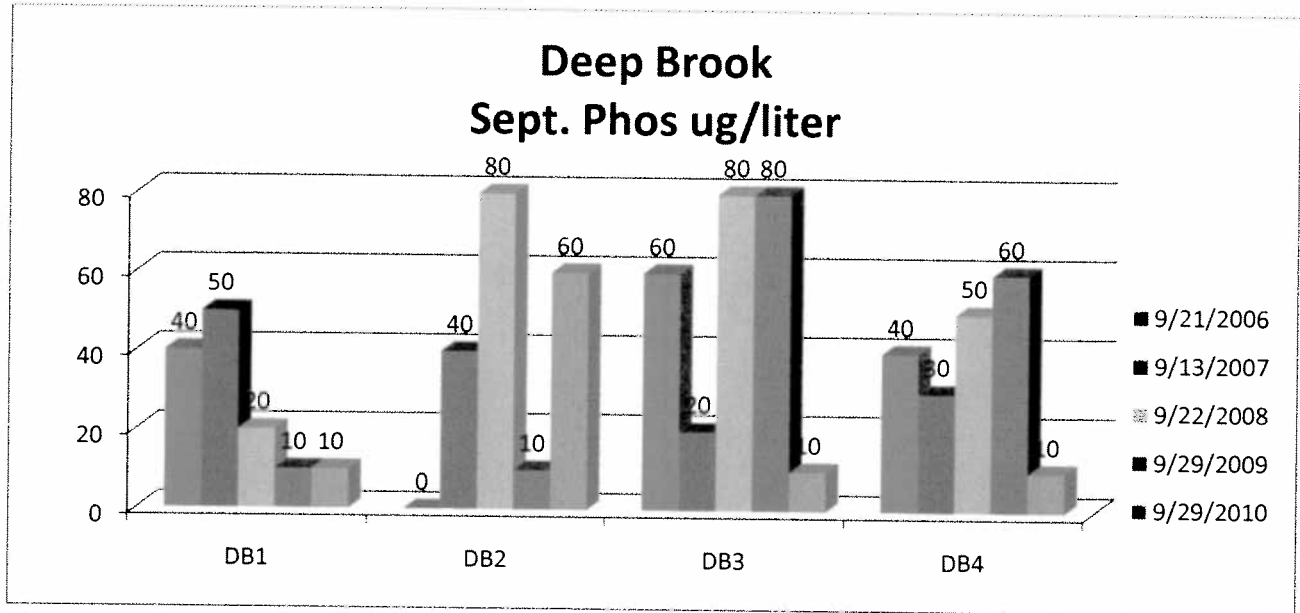
Figure 4

Looking at the yearly averages you could not get a full idea of what was really happening in the river. Once the data was broken up into the different testing months and compared is when a clear trend was shown. **Figures 4 and 5** show the break down separating the months June from September. In September between DB2 and DB3 the variation is generally the same with a wide deviation but when you look at DB2 and DB3 on **Figure 5** you see a clear increase over the years on DB2 from 30-80 and an even steadier decrease over the years from 60-30 for DB3.

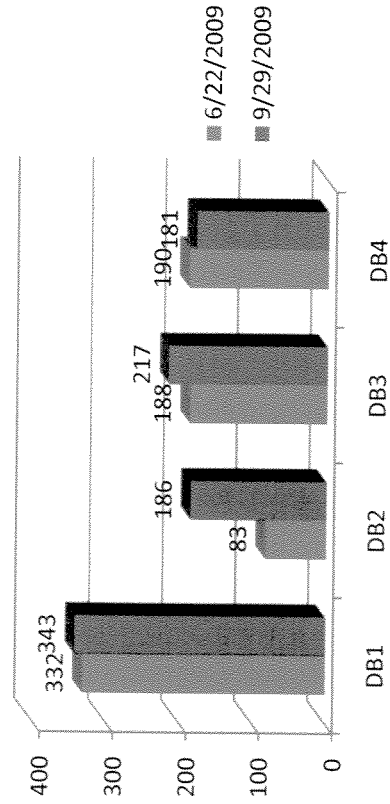
Figure 12

More supporting data shows on **Figure 10-13**, shows the Deep Brook Conductivity comparing a month in September to the corresponding month in June. All the data indicates that there is a huge increase in the Conductivity at site 1.

Deep Brook Conductivity
umhos/cm

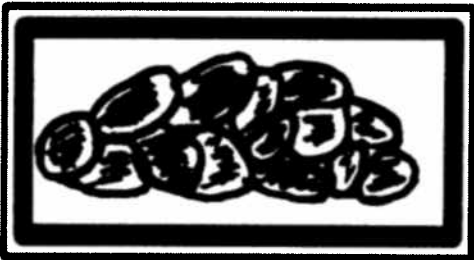
side view of case

- Small oval stone case, turtle shell shape.
- Case is made of 15-25 very small pebbles.
- Underside of the case has 2 round openings.
- Larva body is cylindrical and slightly arc shaped.
- Larvae has light body with dark head and legs.
- No larger than 1/4 inch.

- This caddisfly larva is often attached to the surface of rocks in fast current.
- May not move at all when in the tray. If so it will crawl slowly along the bottom of the tray.

Points of Note:
 This organism can be confused with other small case building caddisflies like *Apatania* and *Neophylax*. This caddisfly can be abundant under appropriate conditions. Look very carefully for these very small caddisfly larvae. It may be easier to located by observing rocks in the stream before any kicks are made.

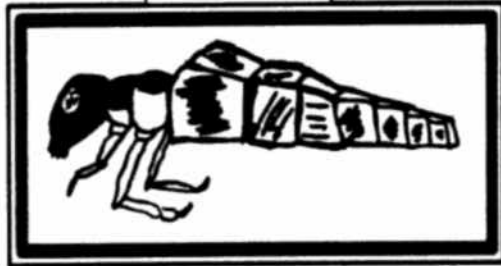
Lepidostoma **Panel 8B**

- Case constructed of organic material only.
- Each case is made from either strips or small blocks.
- Case and larvae taper from front to back.
- Larvae have light bodies with dark head and legs.
- At most 1/2 inch in length.

- Cryptic neither will move around the tray very much.
- Cases may be attached to sticks, leaves, or larger rocks.
- When crawling, they resemble hermit crabs.

Points of Note:
These caddisfly larvae can be very abundant under the appropriate conditions. Look carefully when the sample contains old leaves, sticks, or bark.

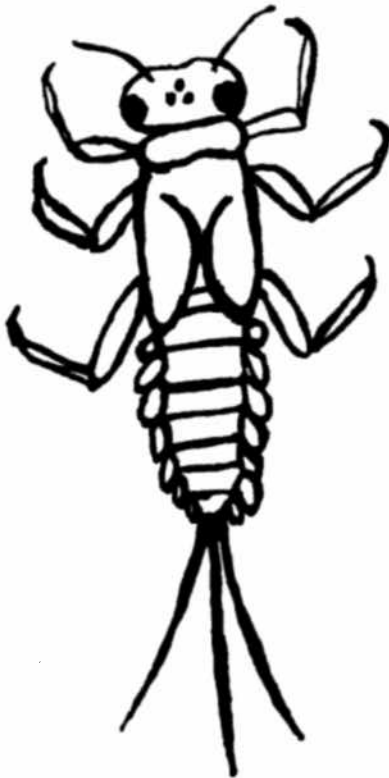
FLAT-HEAD MAYFLY

Genus *Stenonema*
Family Heptageniidae
Order Ephemeroptera

- Very flat body with long thin legs.
- 3 very long tails at the end of the abdomen.
- Single set of wing pads.
- Small round gills on the sides of the abdomen.
- Very broad flat head with large eyes.

This may fly can be found in many of the streams across Connecticut. They can be found by slowly lifting cobbles out of the water. They may run to the other side of the rock. Be sure not to confuse this organism with the 2-tailed version (*Epeorus*). The legs, gills, and tails tend to break off during the collection process.

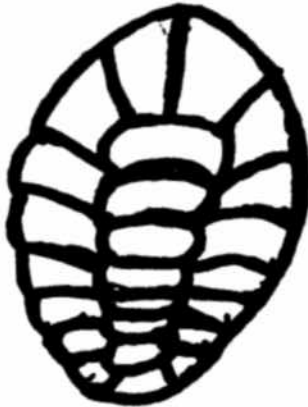
Top view

Genus *Psephenus*
Family Psephenidae
Order Coleoptera

- Small disc shape organism.
- Very flat.
- Uniformly brown.
- No visible head or legs from top view.

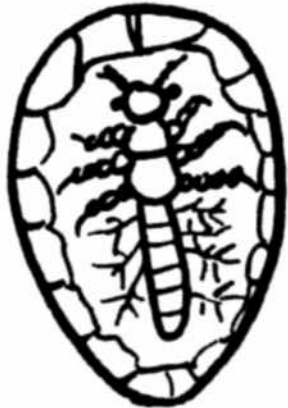
Bottom view

- Sticks very well to rocks.
- Glides along the bottom of the tray.
- May curl up when disturbed
- Very cryptic.

Water penny beetle larva are very distinctive. They can also be very hard to locate in the field. Look very closely at the surfaces of rocks. Water penny beetle larva will adhere extremely close to the surface. These organisms can be locally abundant when conditions are appropriate.
